# **Port Royal Condominium**

## **Balconies, Walkways and Exterior Building Condition Survey Report**

Prepared By  
**James E. Emory, P.E.**  
Florida Registered Professional Engineer  
and Special Inspector #60965

**January 20, 2023**

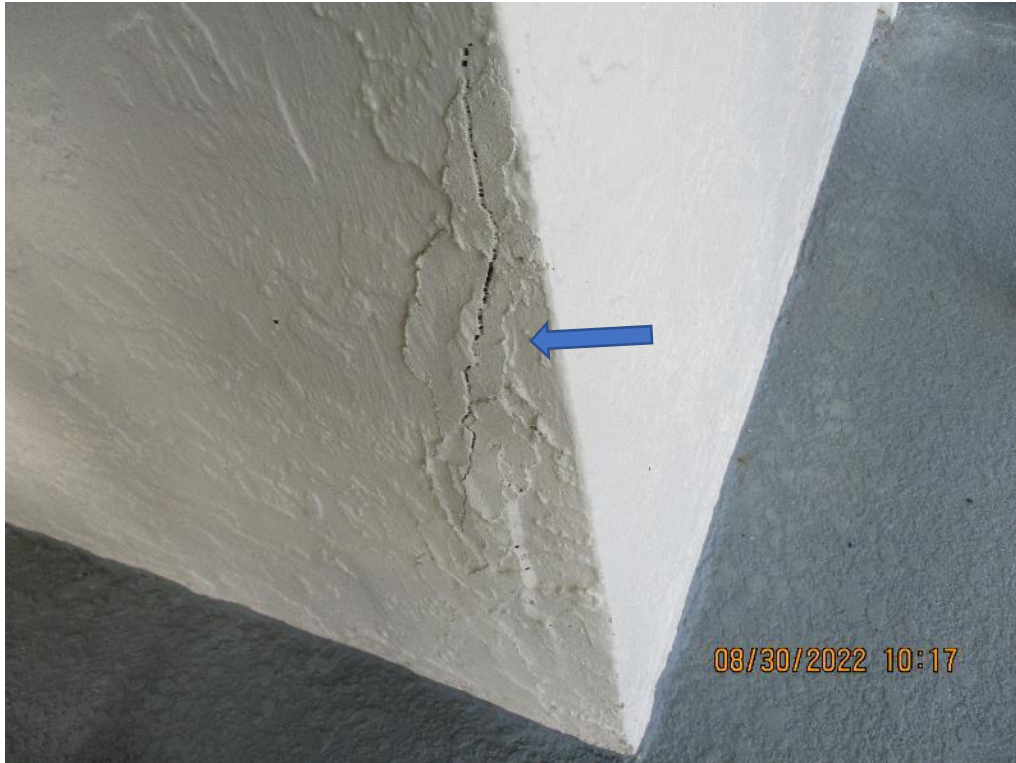
**Column spall due to reinforcing steel corrosion (Unit 151)**

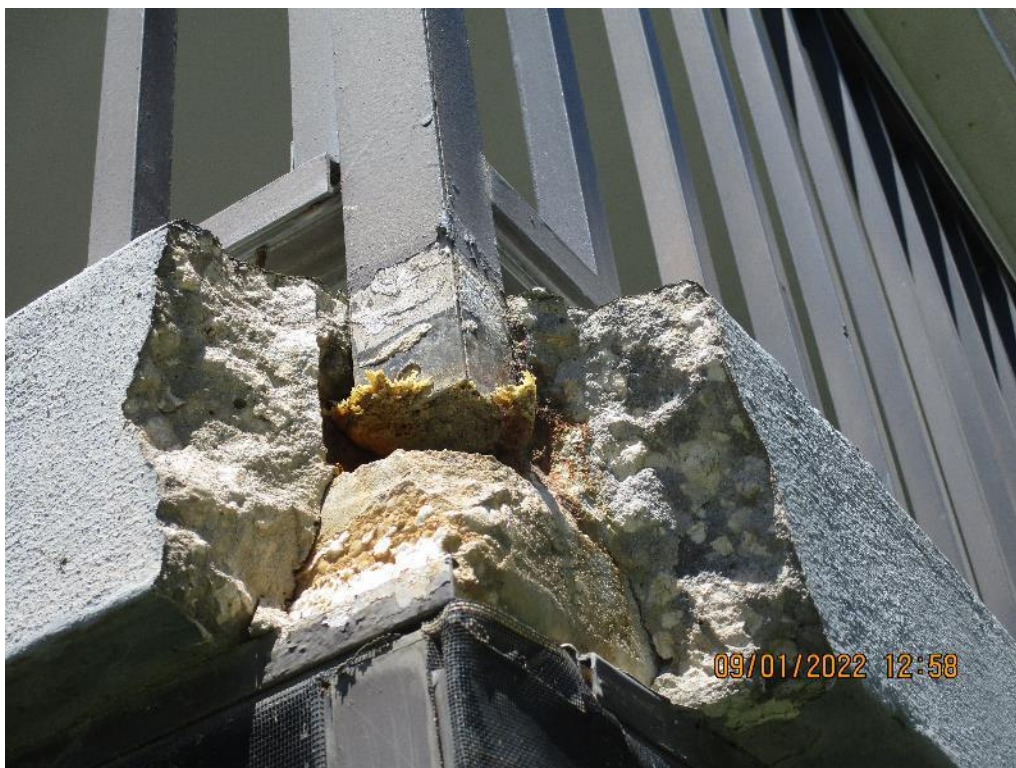
**Concrete damage at foam-filled rail post**

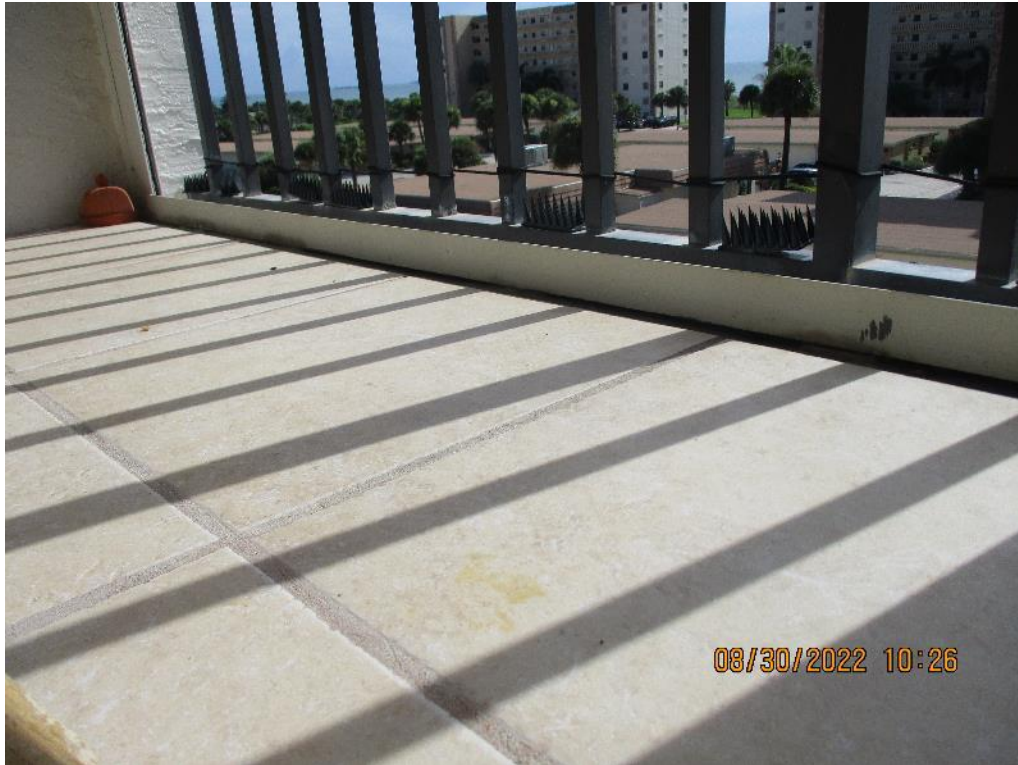
Drainage inhibited by tiles and hurricane shutters without any shims under tracks

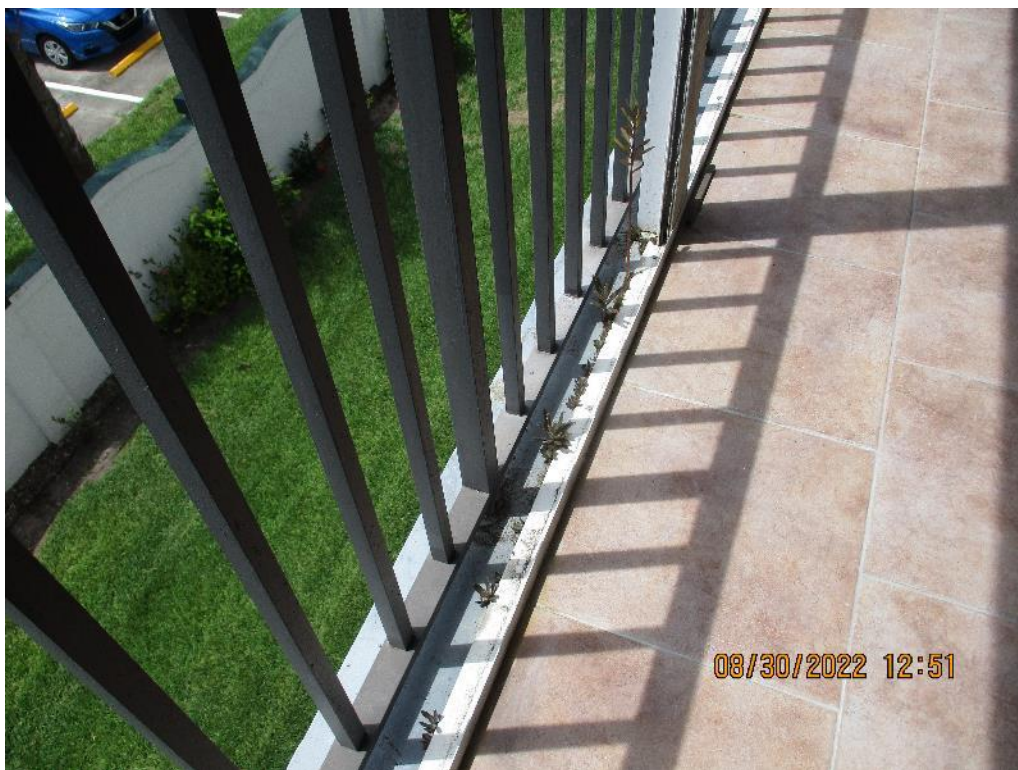
Drainage inhibited by hurricane shutters and tile holding moisture allows vegetation to grow.

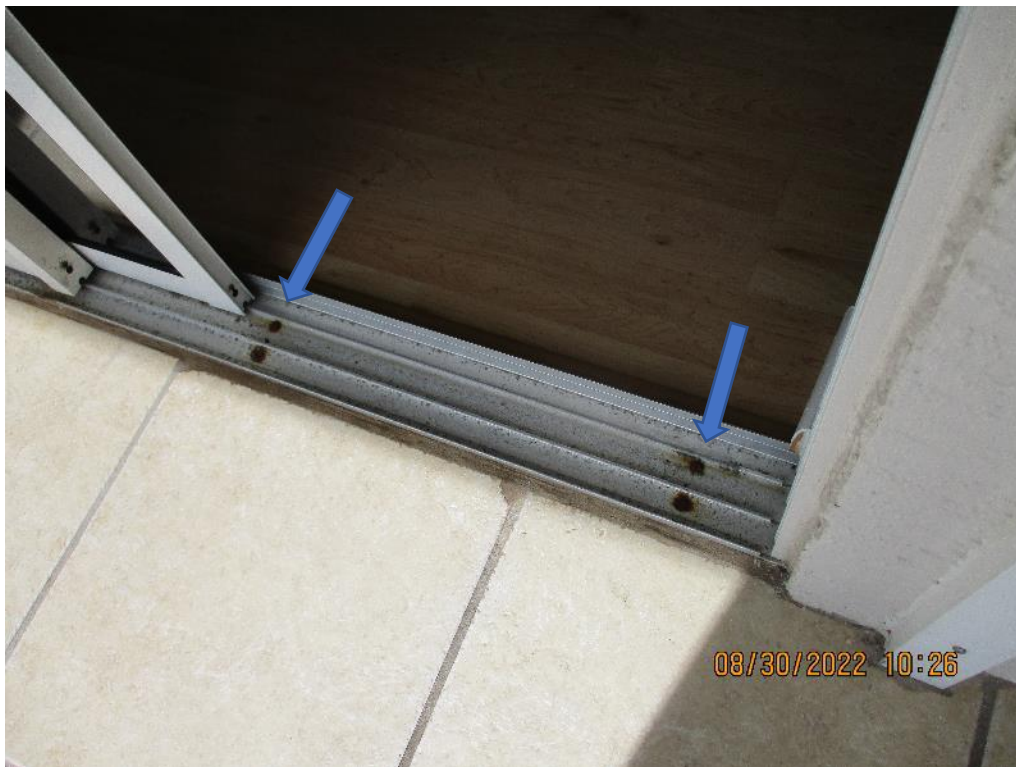
Corroded fasteners in sliding glass door track, allowing saltwater intrusion and structural damage

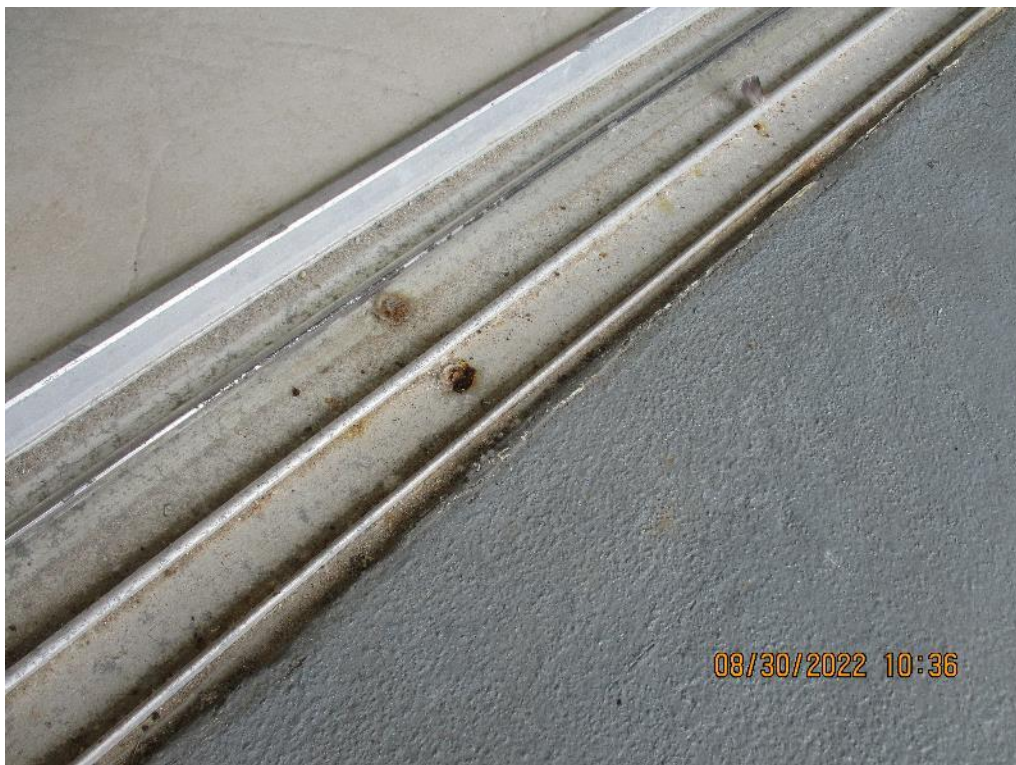
Corroded fasteners in sliding glass door track, allowing saltwater intrusion and structural damage

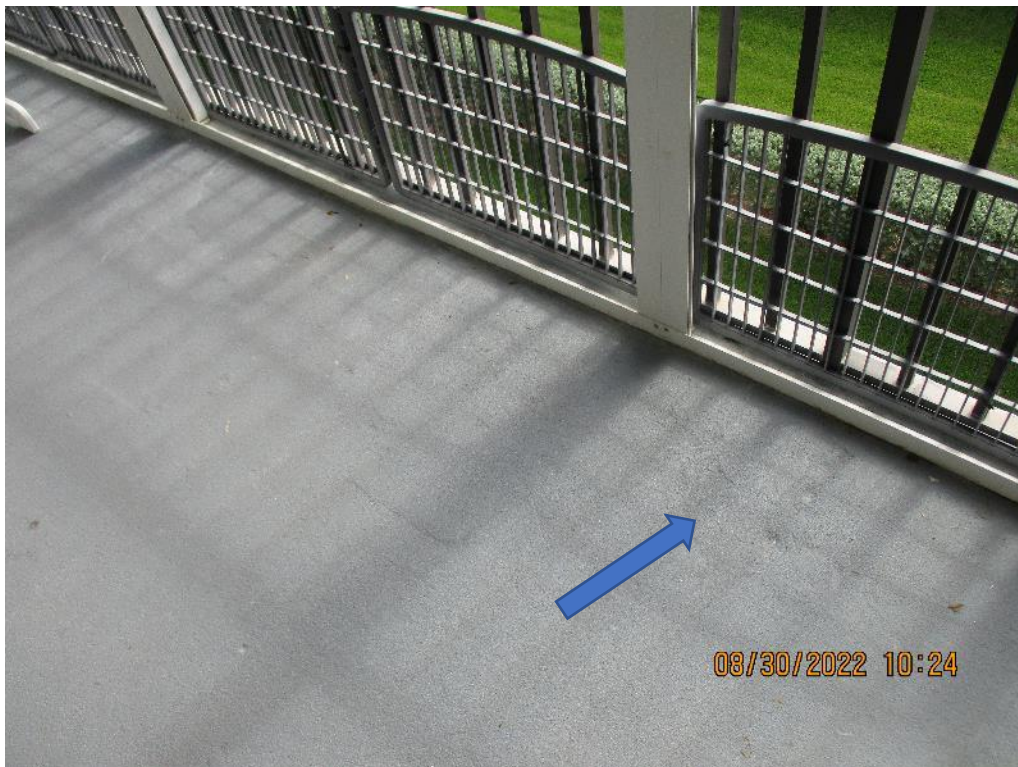
**Floor spall due to reinforcing steel corrosion at blocked shutter drainage**

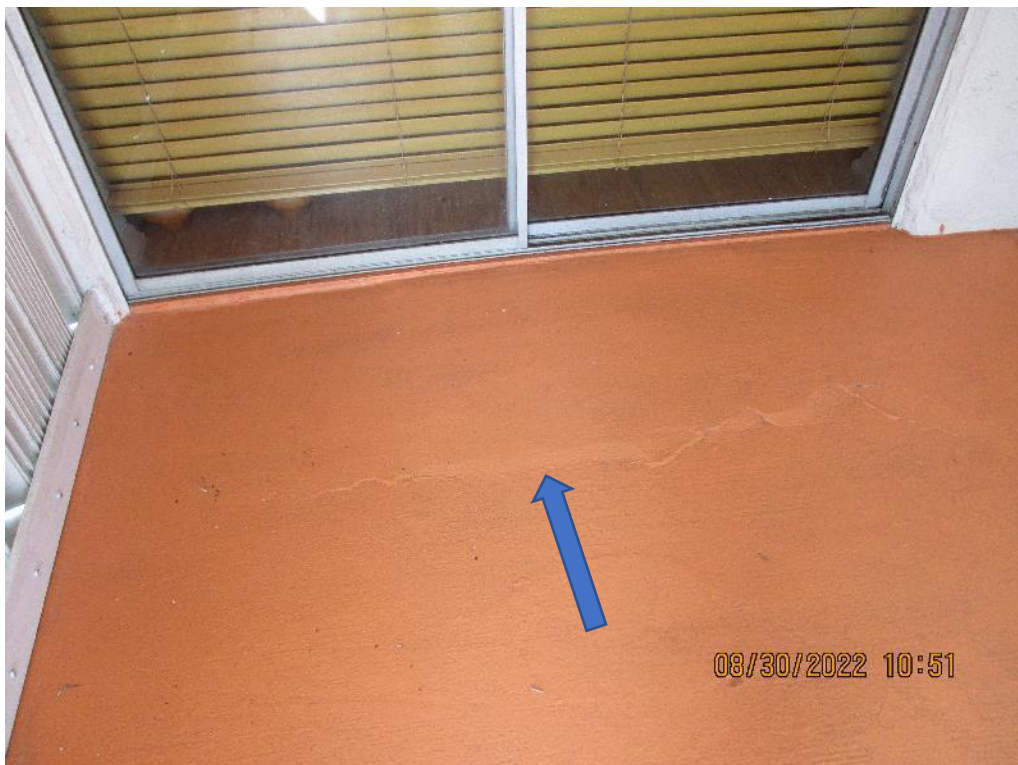
**Example view of floor concrete spalling at sliding glass door  
due to reinforcing steel corrosion (Unit 203)**

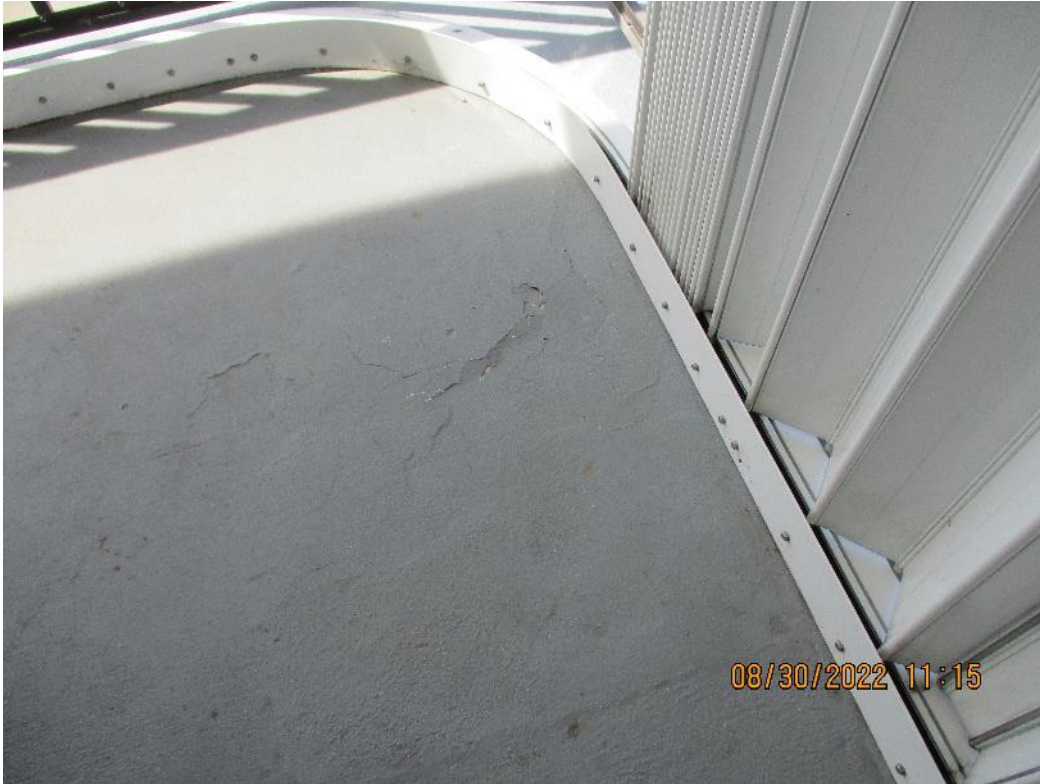
Floor surface concrete spalling due to reinforcing steel corrosion

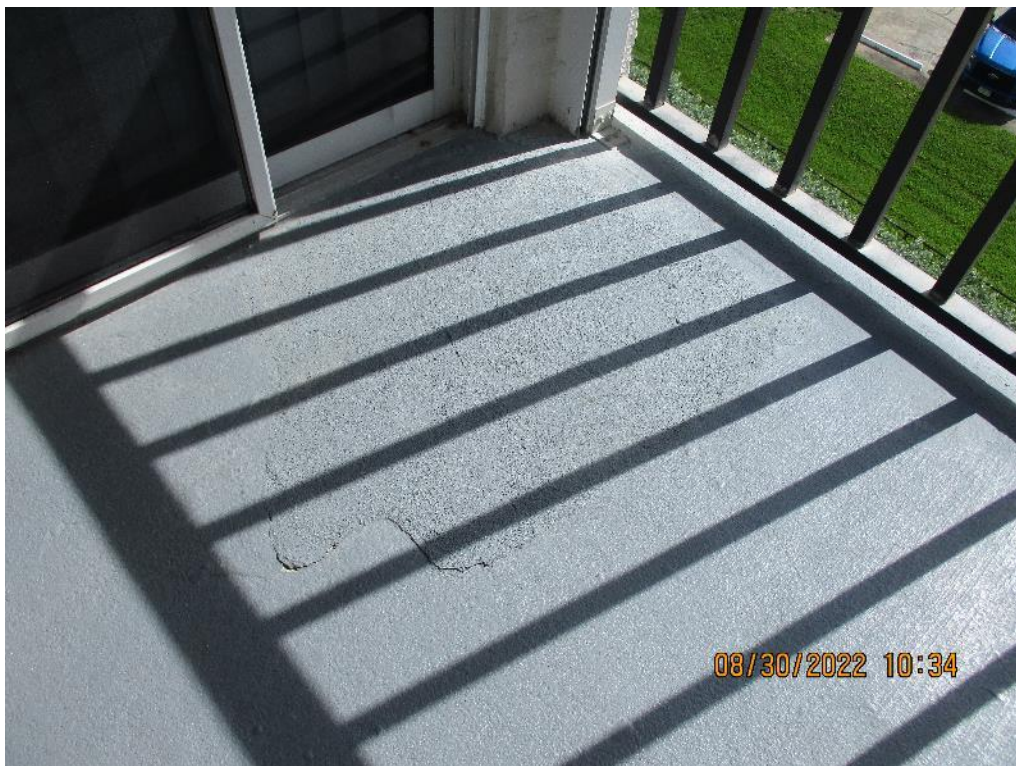
Past spall repair in failure

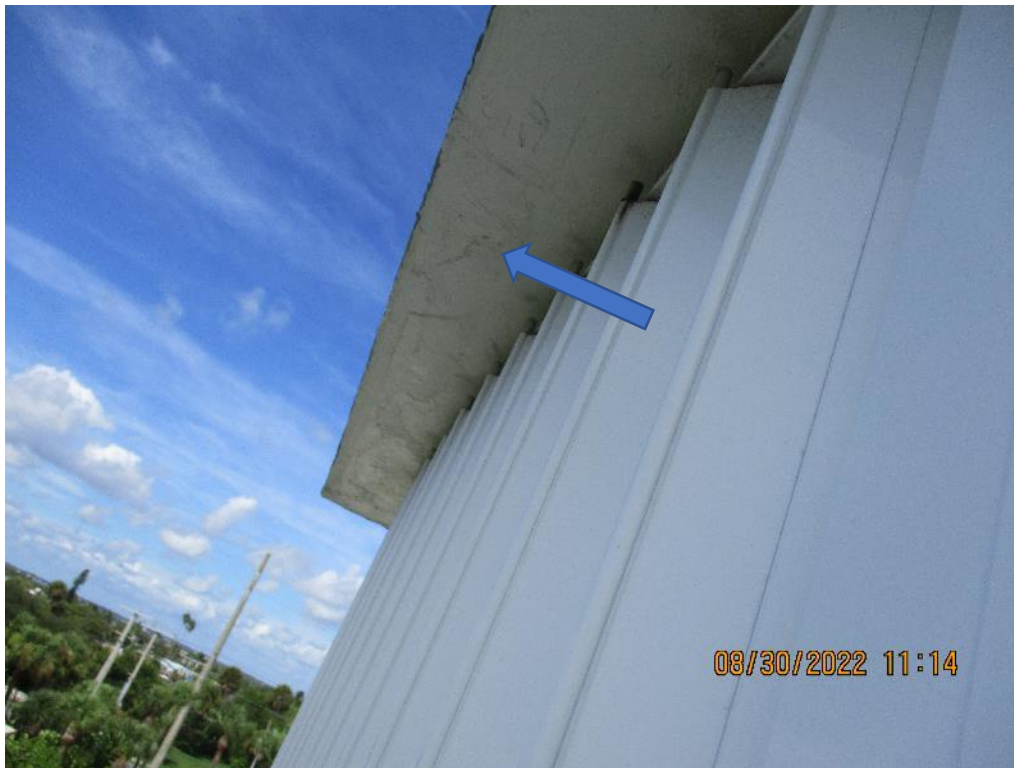
**Balcony slab edge spall repair in failure**

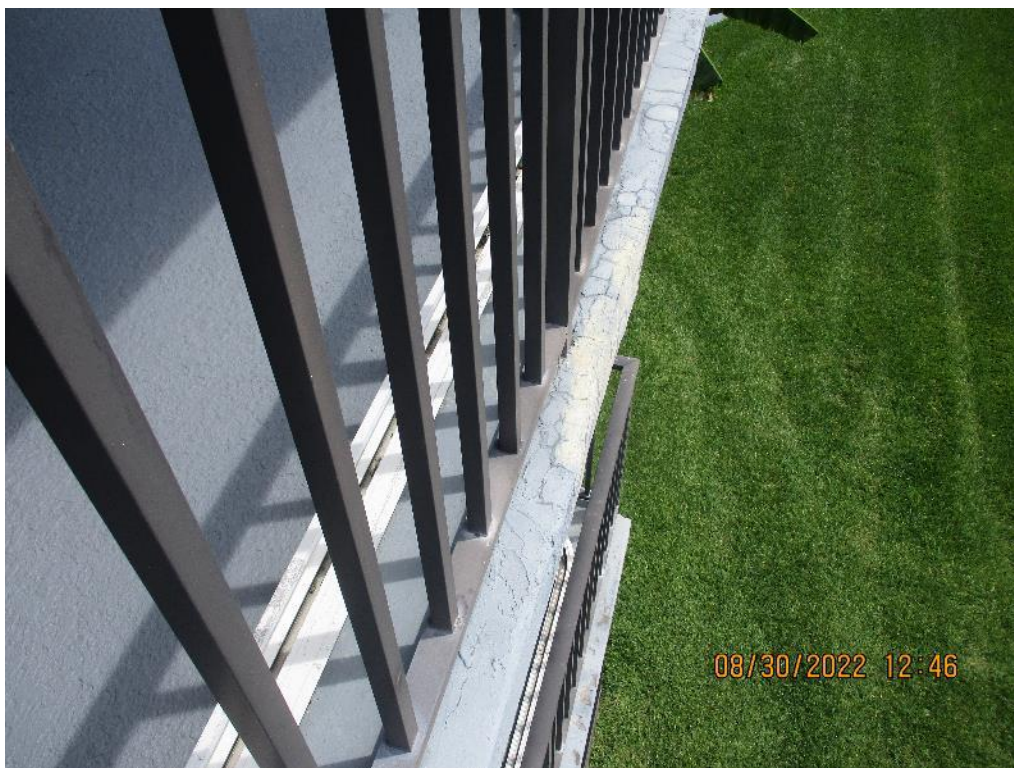
**Balcony slab edge spall repair in failure**

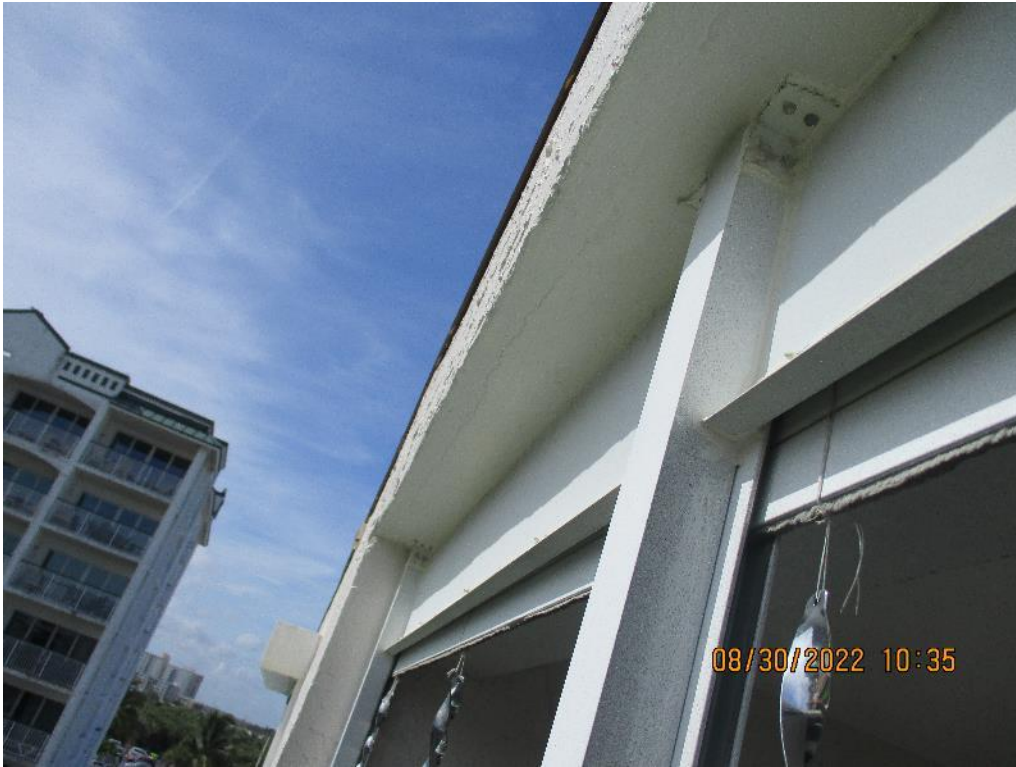
Edge spall along roof

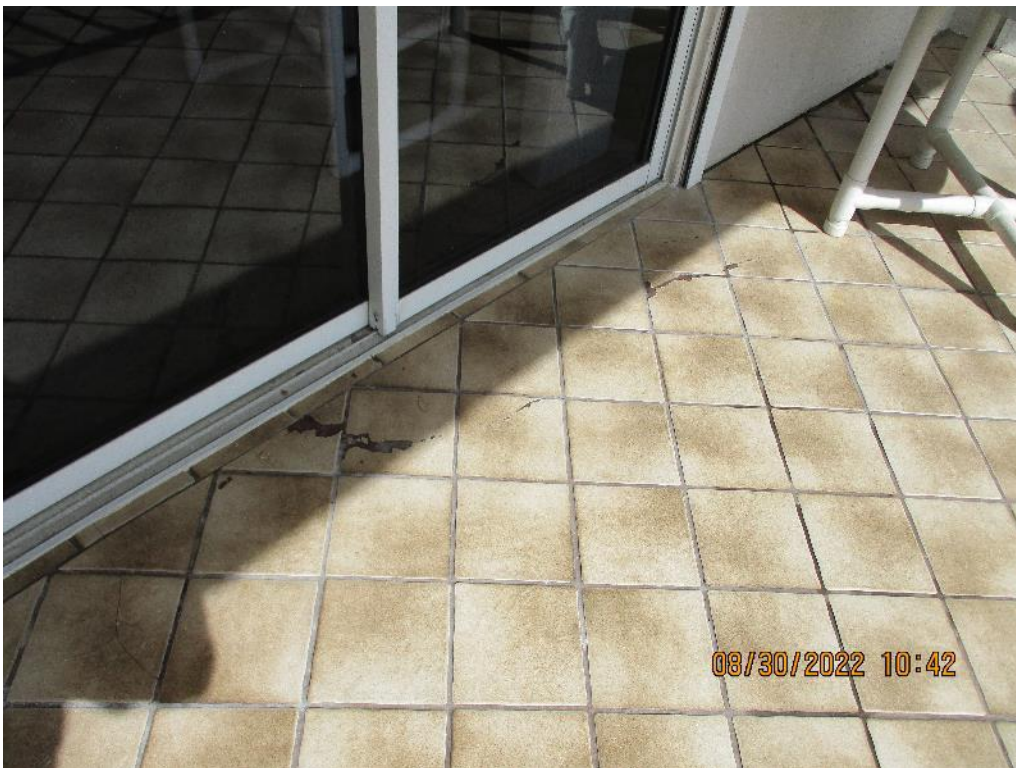
Cracking tile is often an indication of concrete spalling below

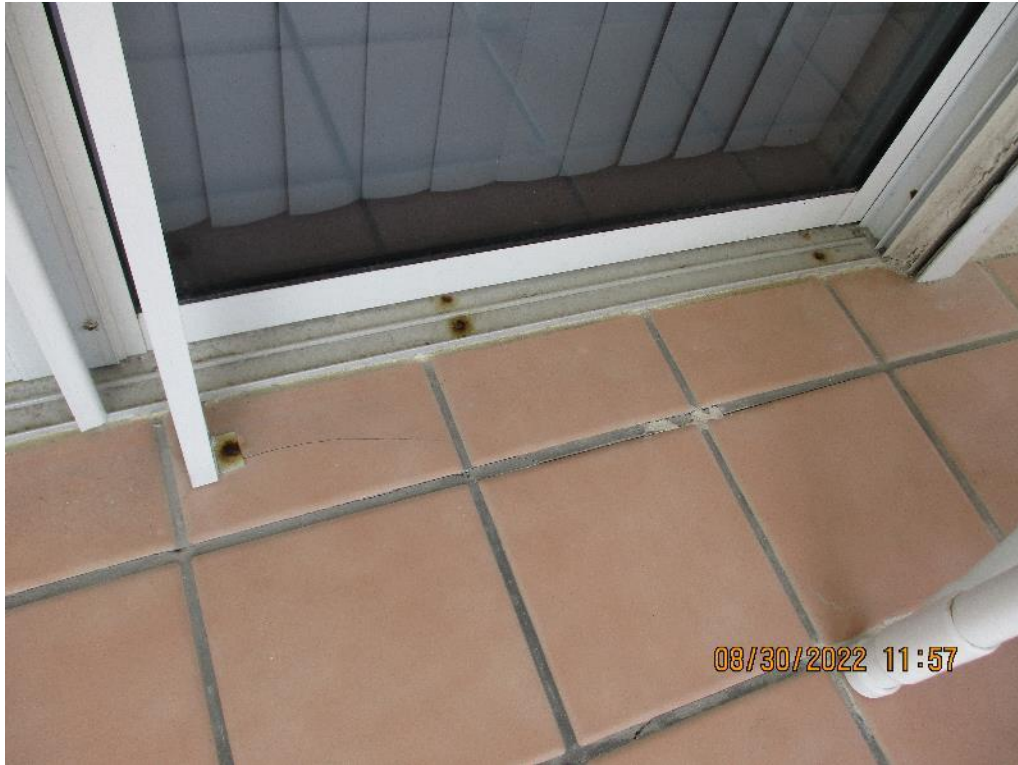
Corroded fasteners on sliding glass door and shutter tracks; cracking tile indicative of spalling below

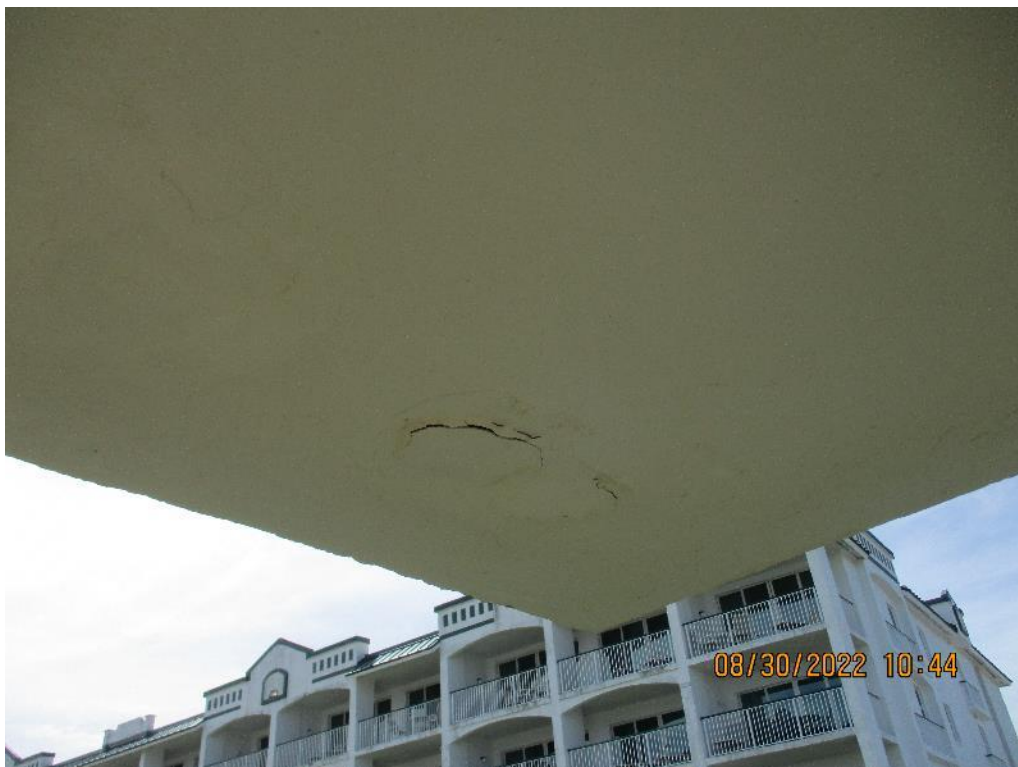
Example view of ceiling spall due to reinforcing steel corrosion

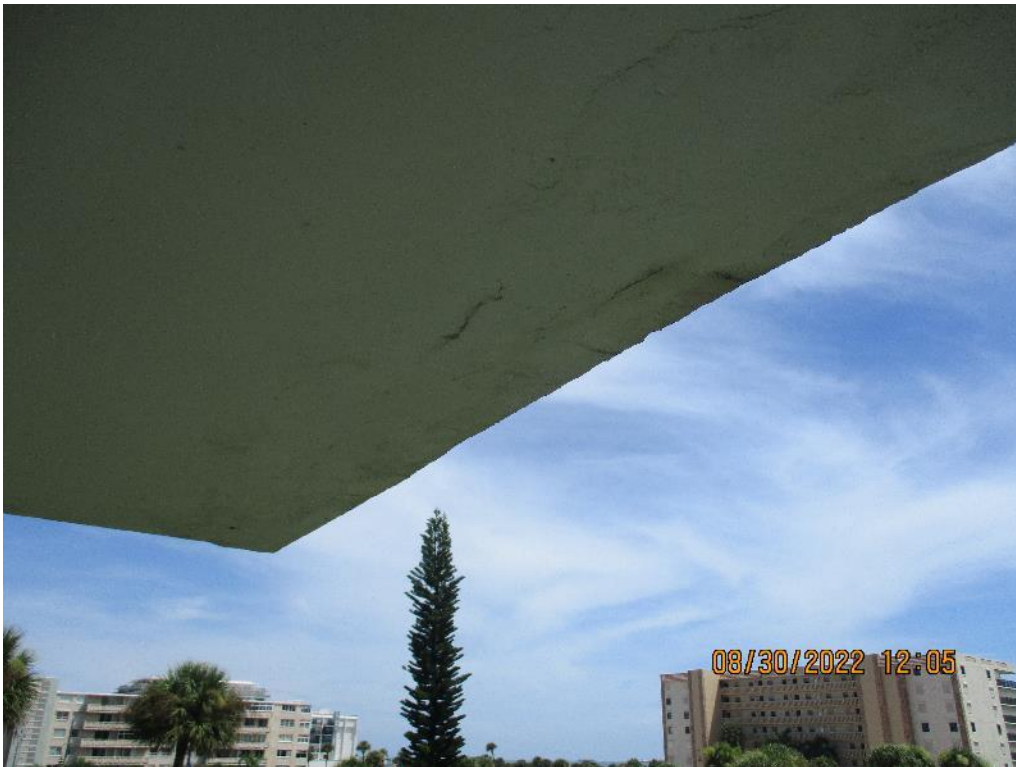
Edge spalls at the ceiling due to reinforcing steel corrosion

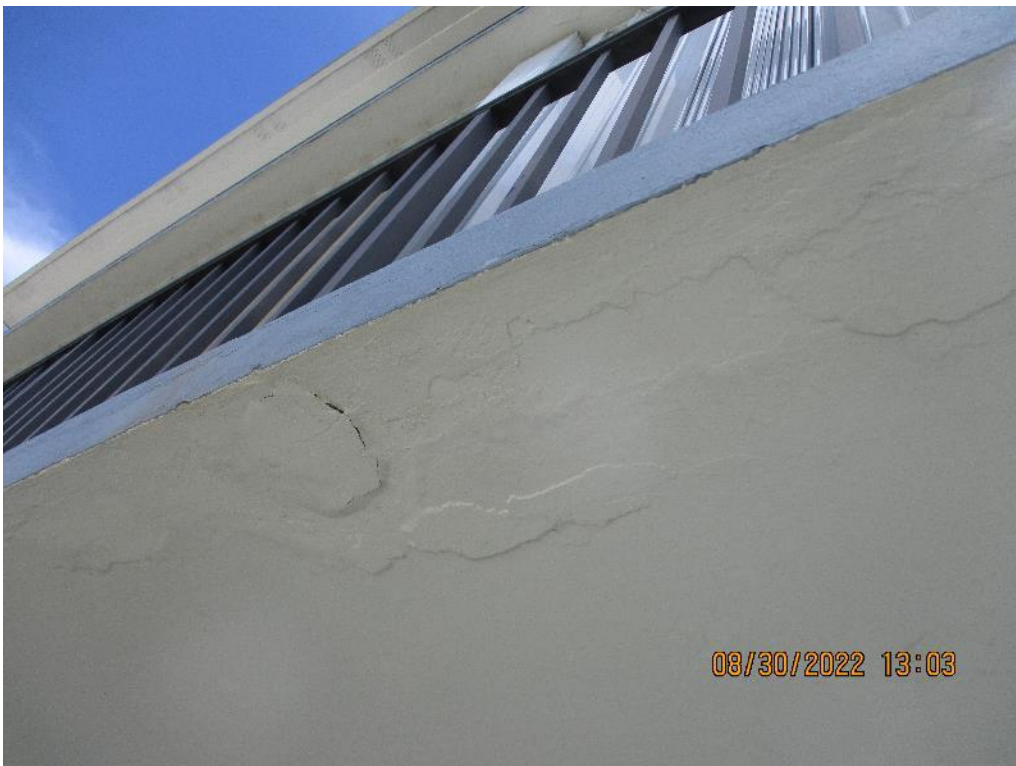
Edge spalls at the ceiling due to reinforcing steel corrosion

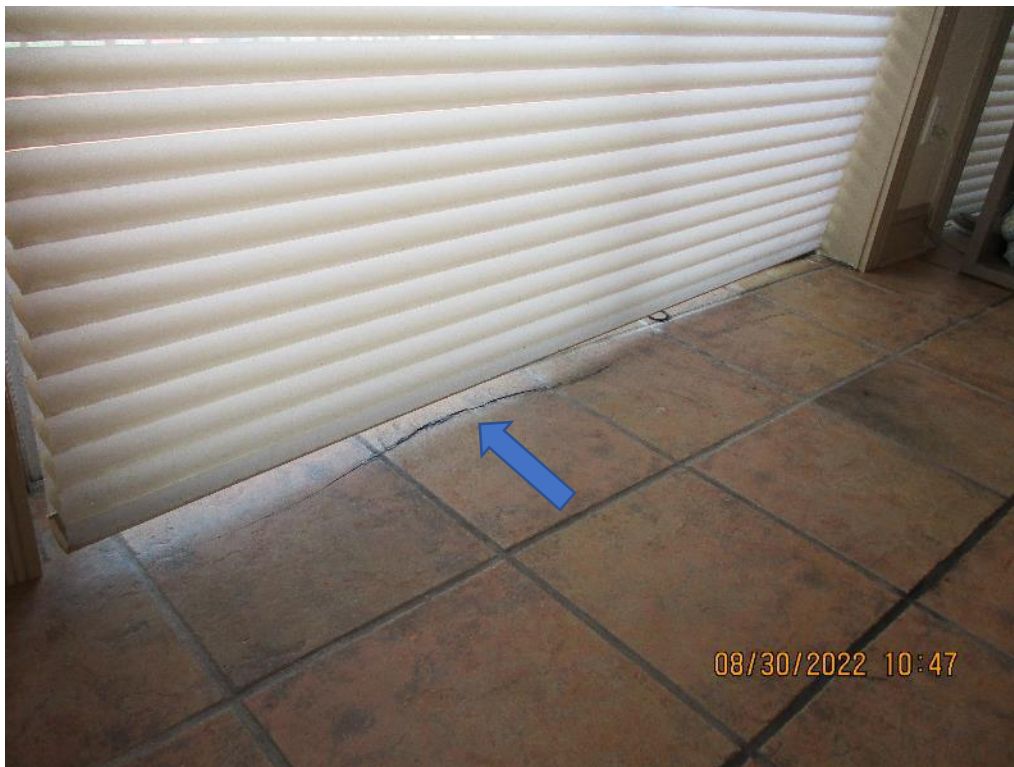
Interior tile cracking indicative of spalling below

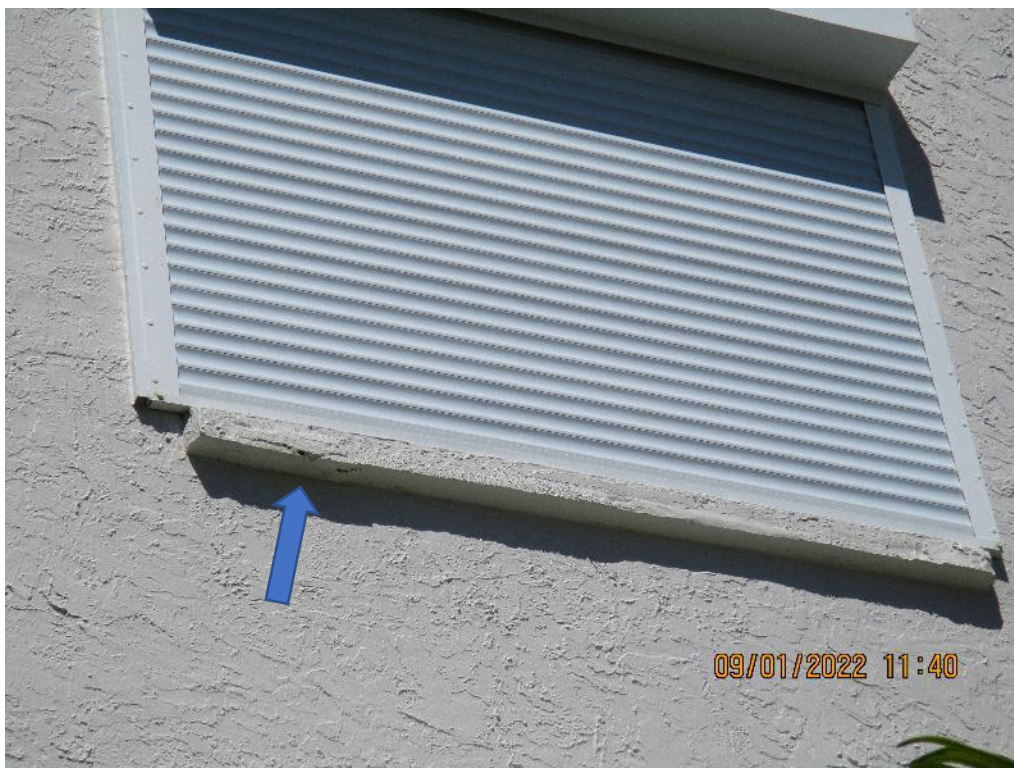
Window sill spall on building exterior

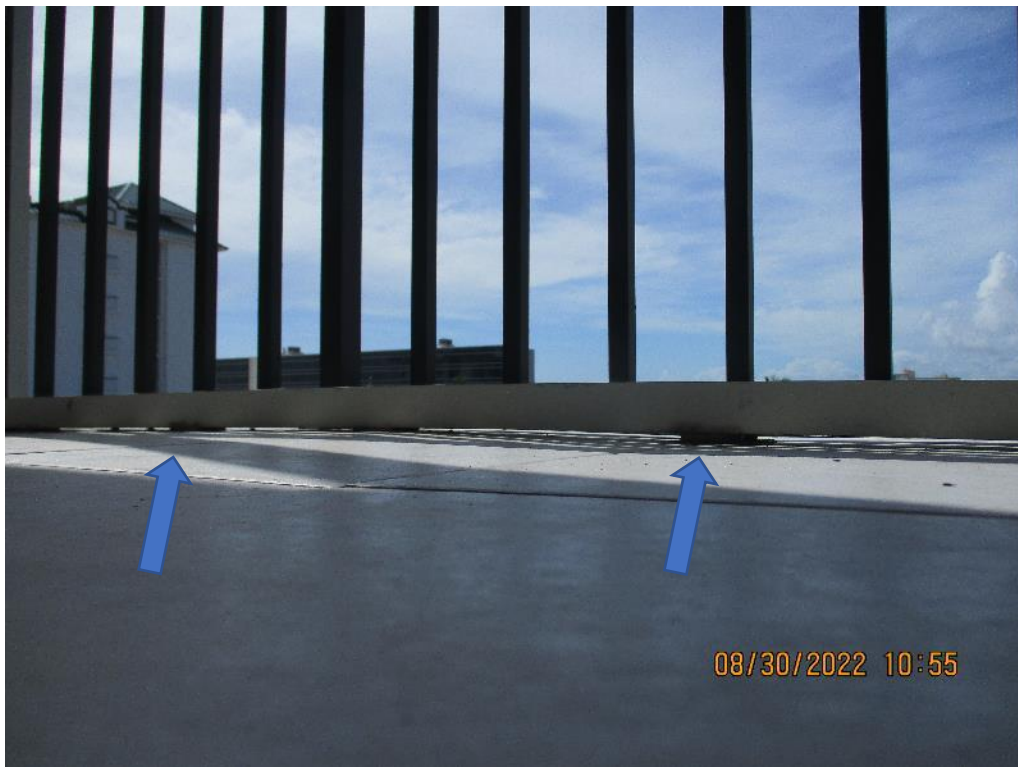
Shutter track with installed shims to promote positive drainage

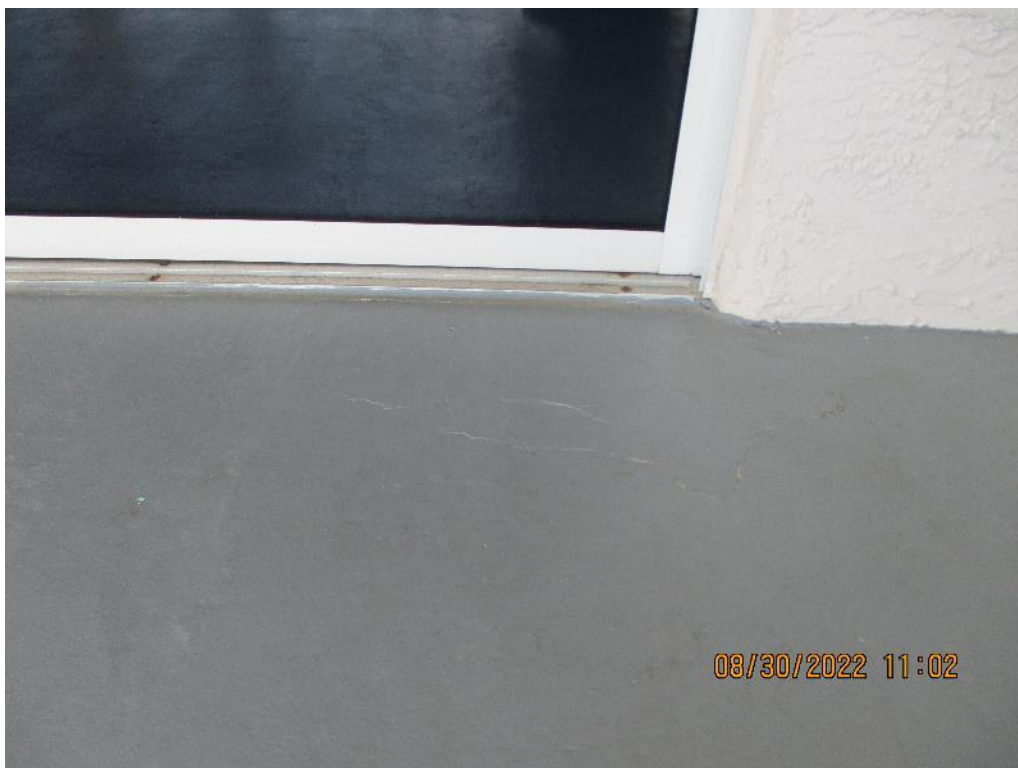
Concrete spalling at sliding glass door

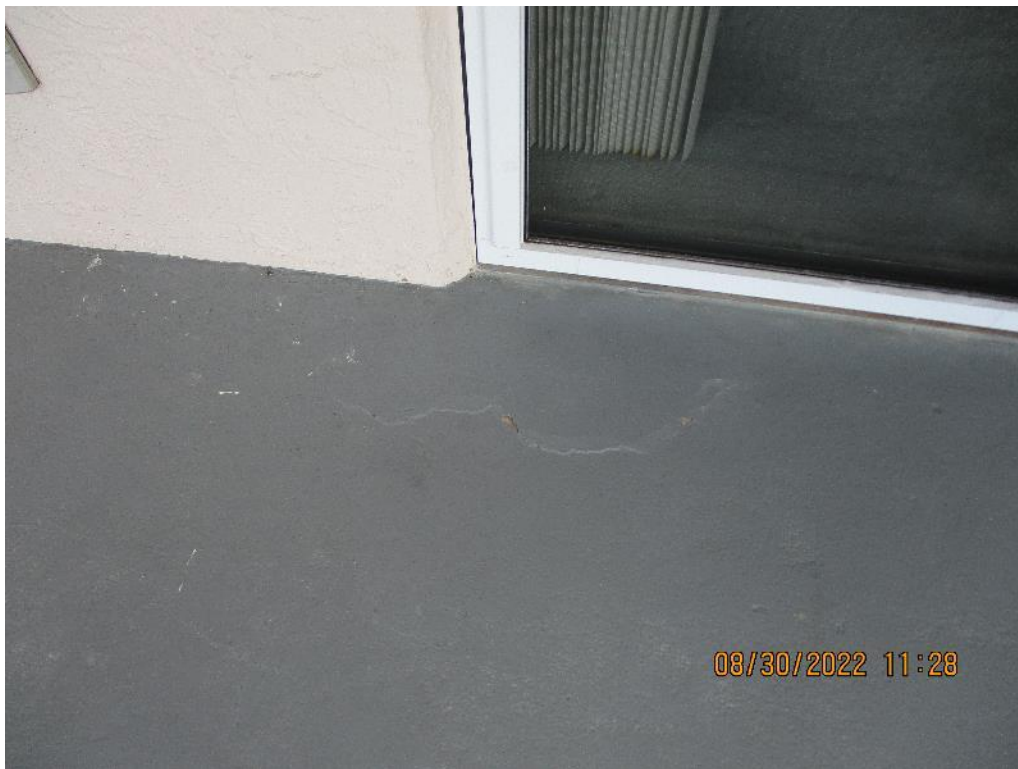
Concrete spalling at sliding glass door

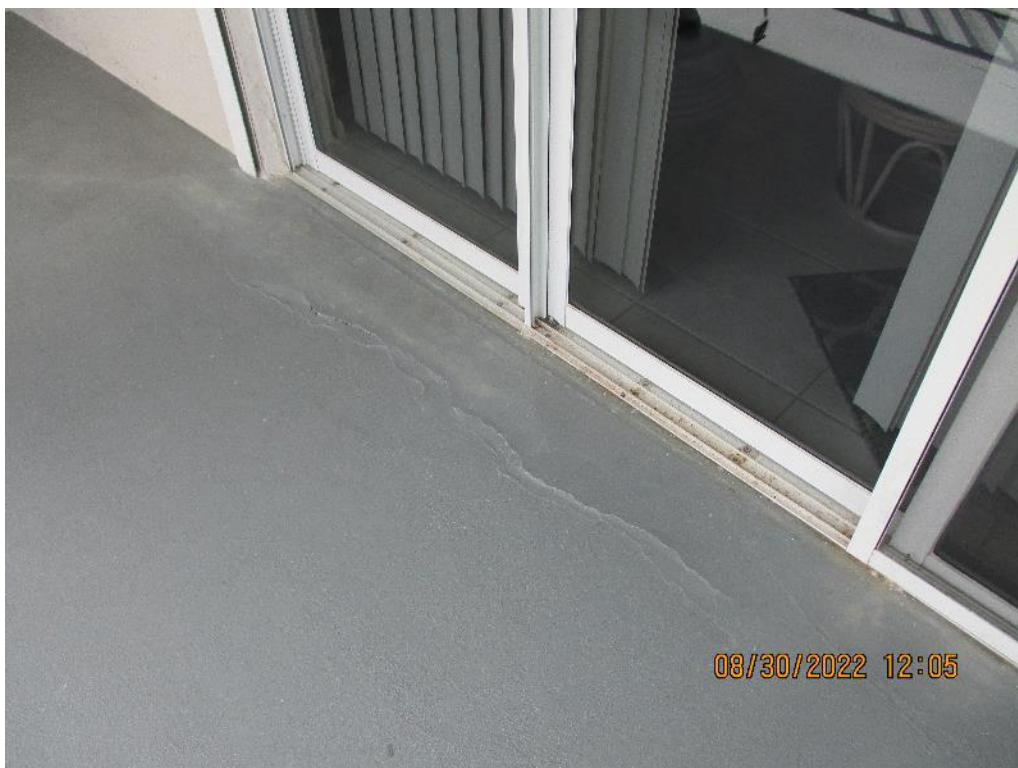
Concrete spalling at sliding glass door

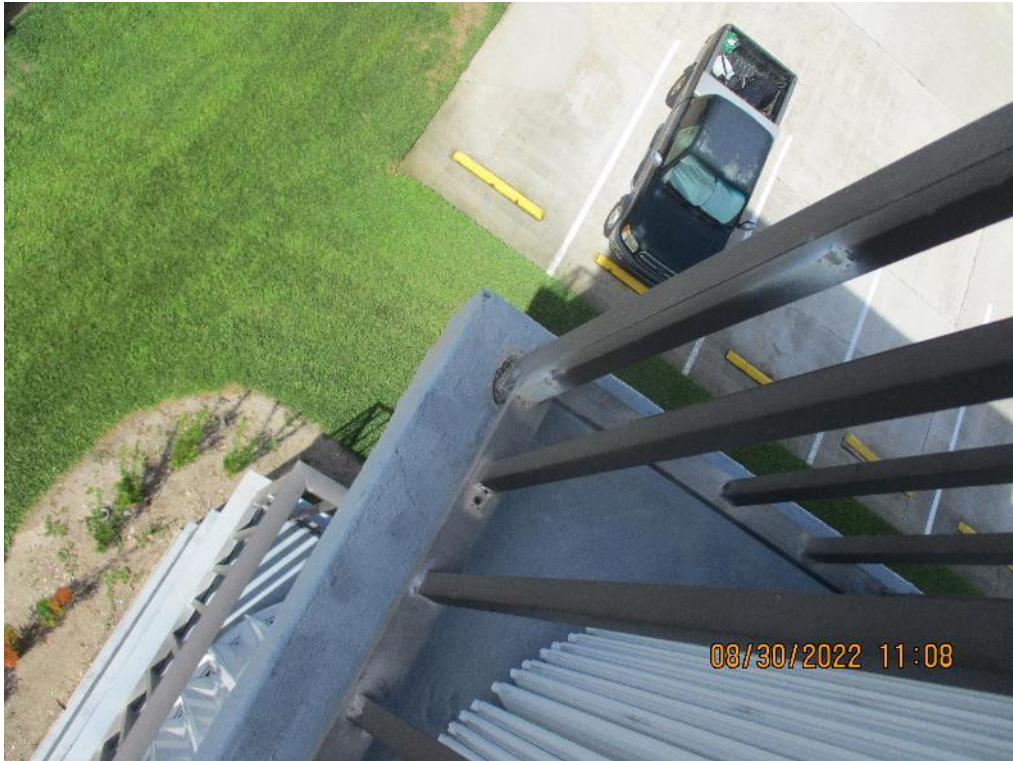
Railing deterioration

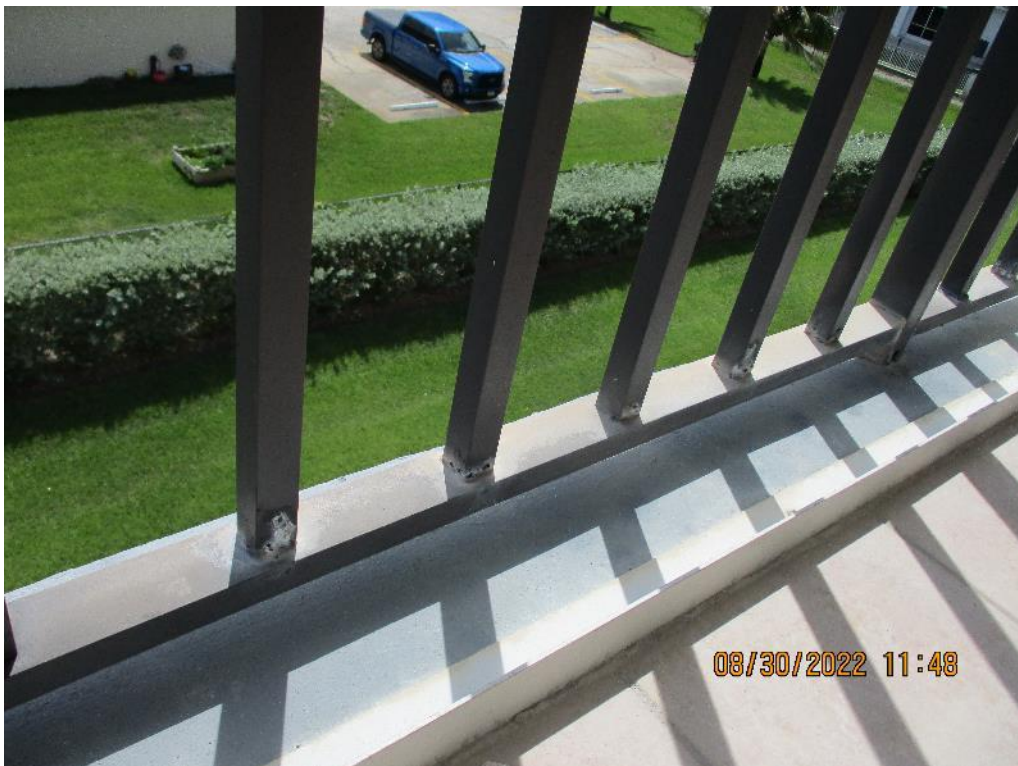
Railing deterioration

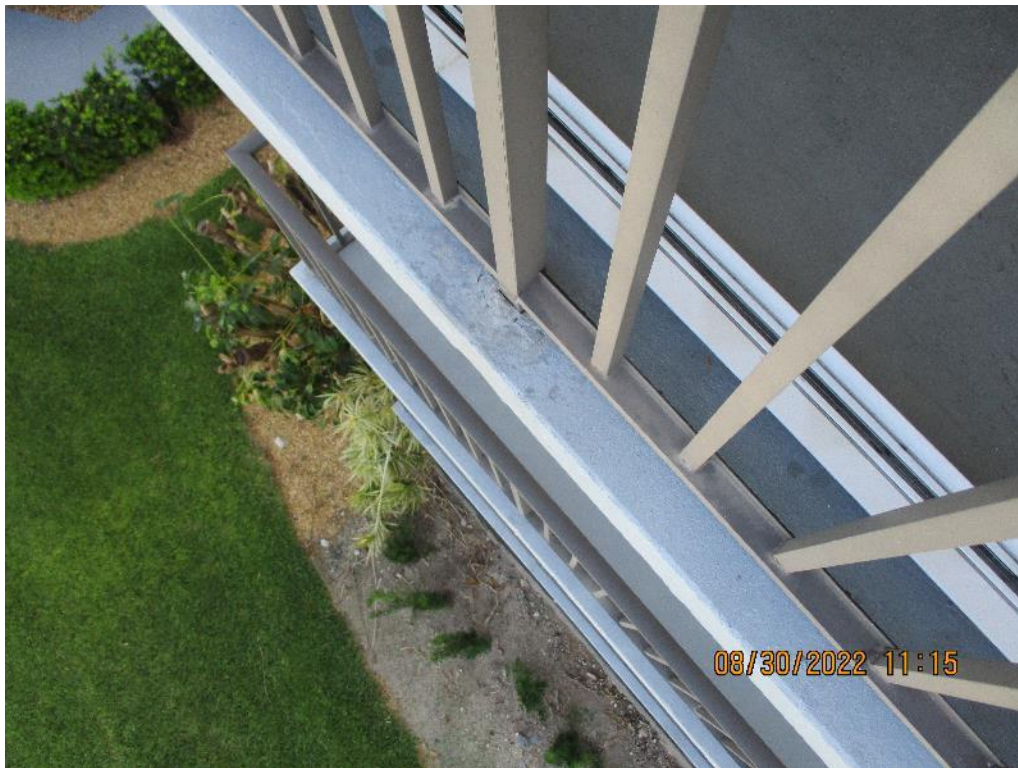
Example view cored railings

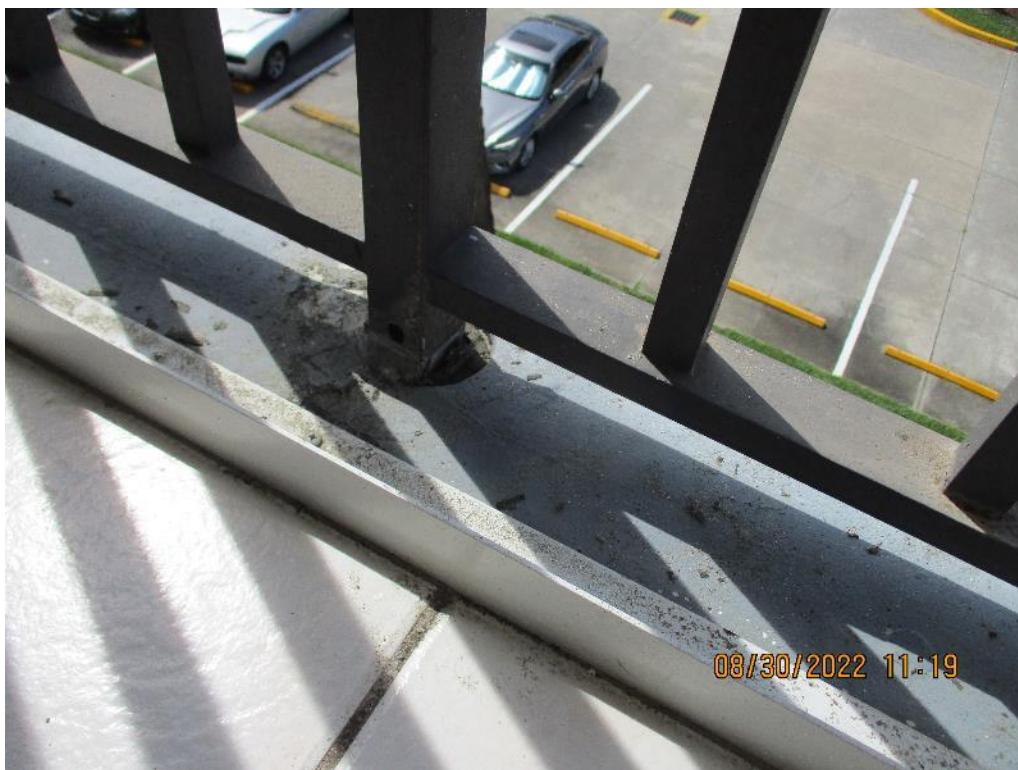
Railing core starting to fail

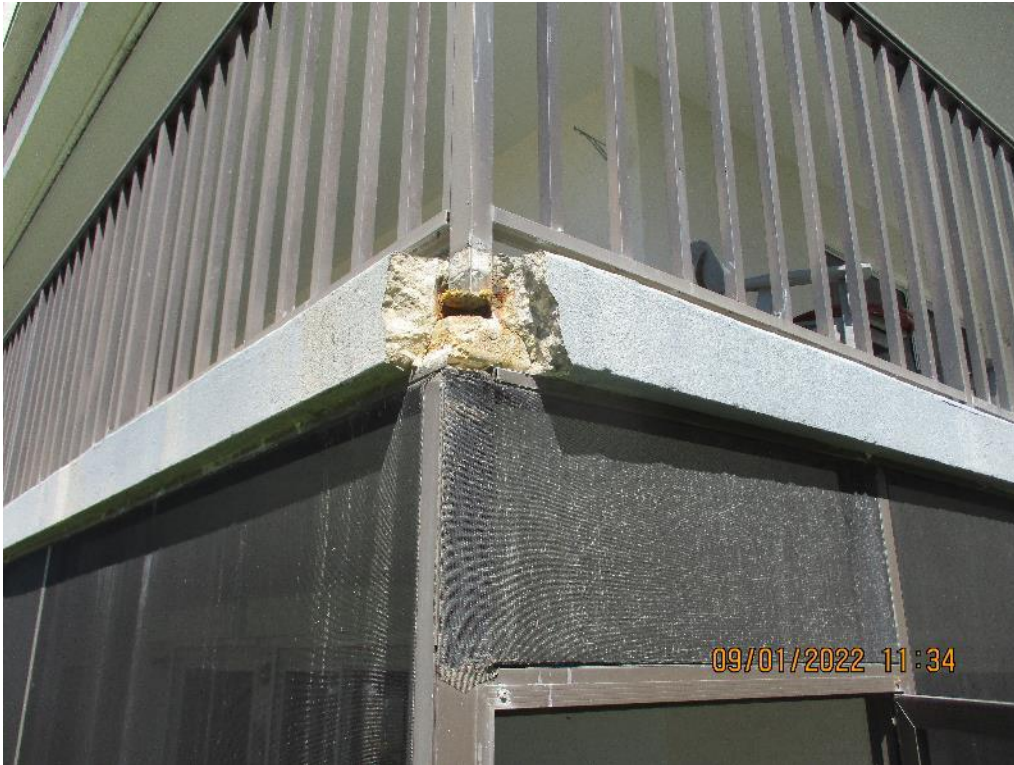
Cored railing causing edge spalling
