# **Port Royal Condominium**

## **Balconies, Walkways and Exterior Building Condition Survey Report**

Prepared By  
**James E. Emory, P.E.**  
Florida Registered Professional Engineer  
and Special Inspector #60965

**January 20, 2023**

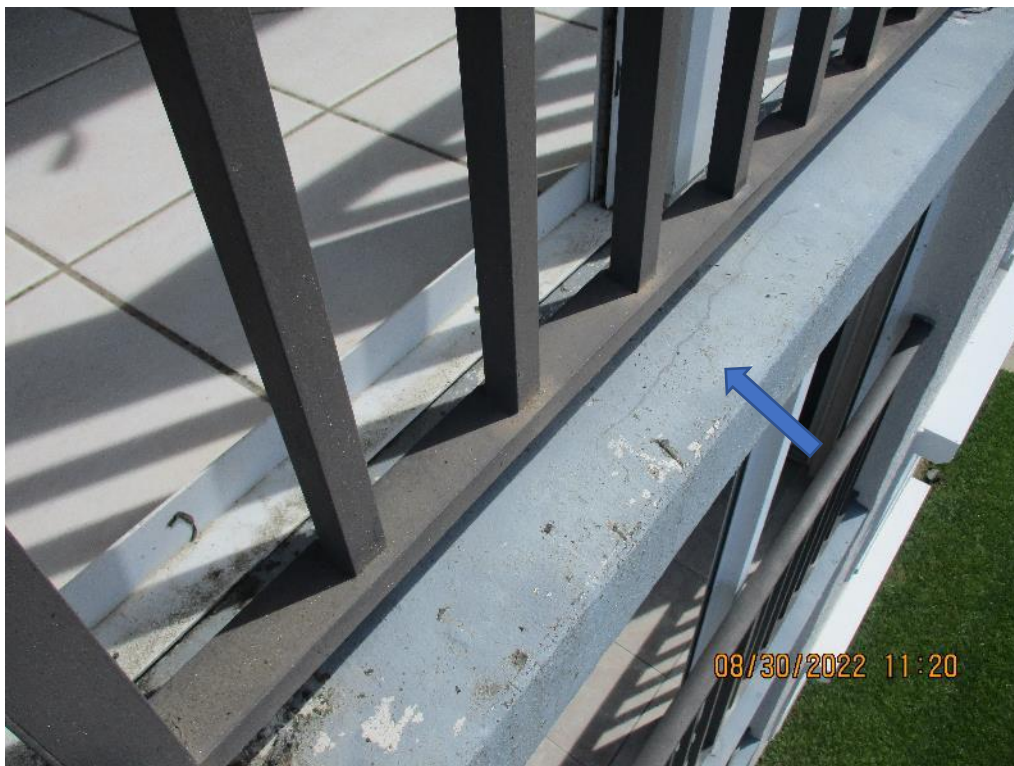
Edge spall due to reinforcing steel corrosion

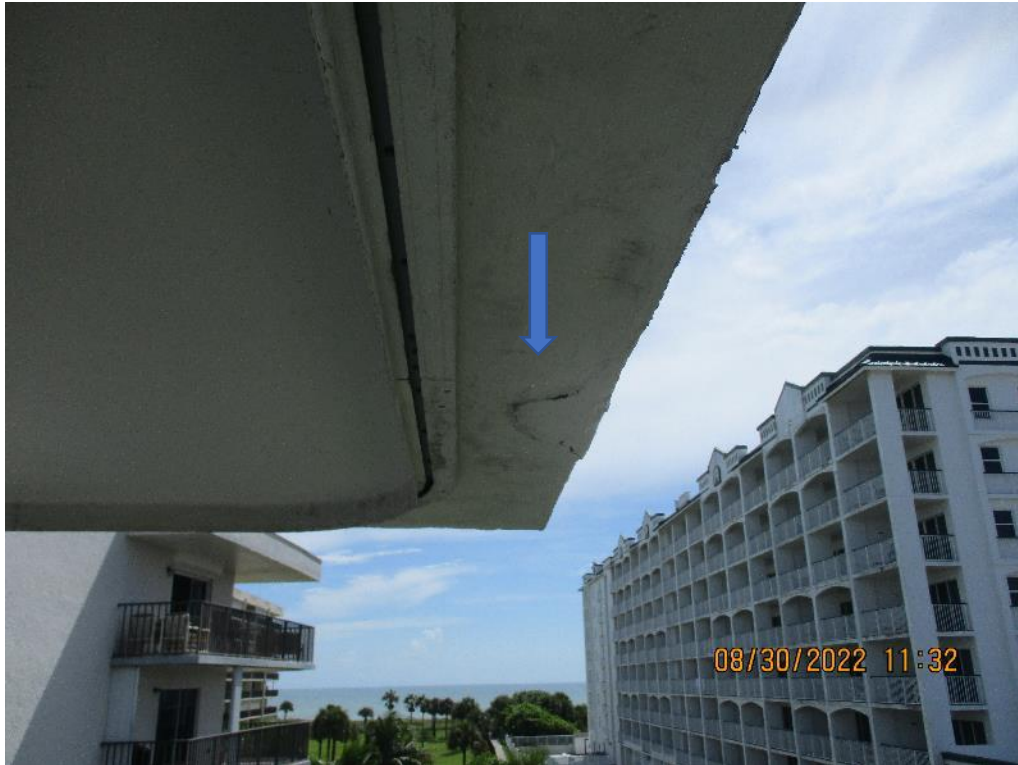
Edge spall on ceiling due to reinforcing steel corrosion

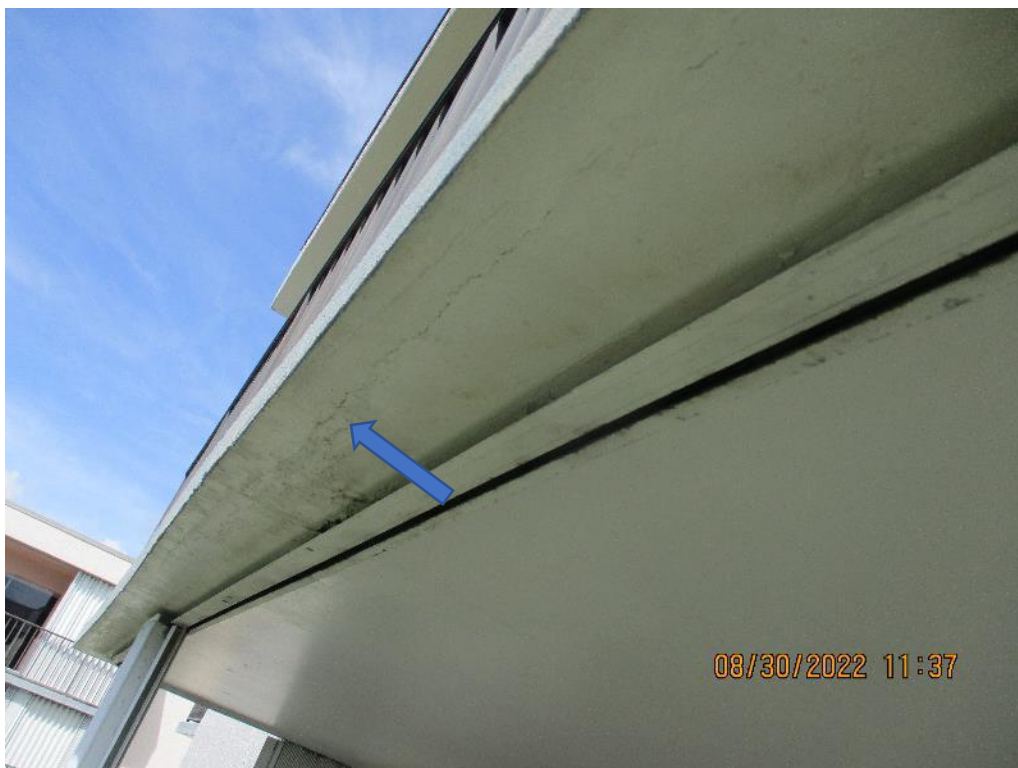
Edge concrete spalling due to reinforcing steel corrosion

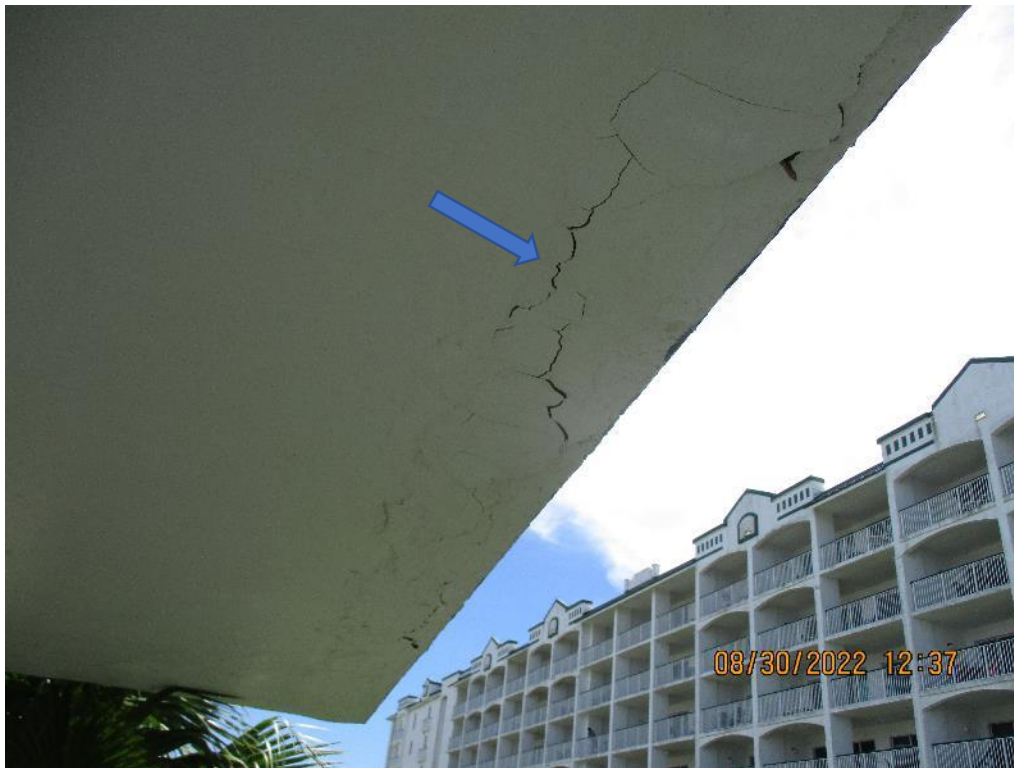
Concrete spalling along balcony edge due to reinforcing steel corrosion

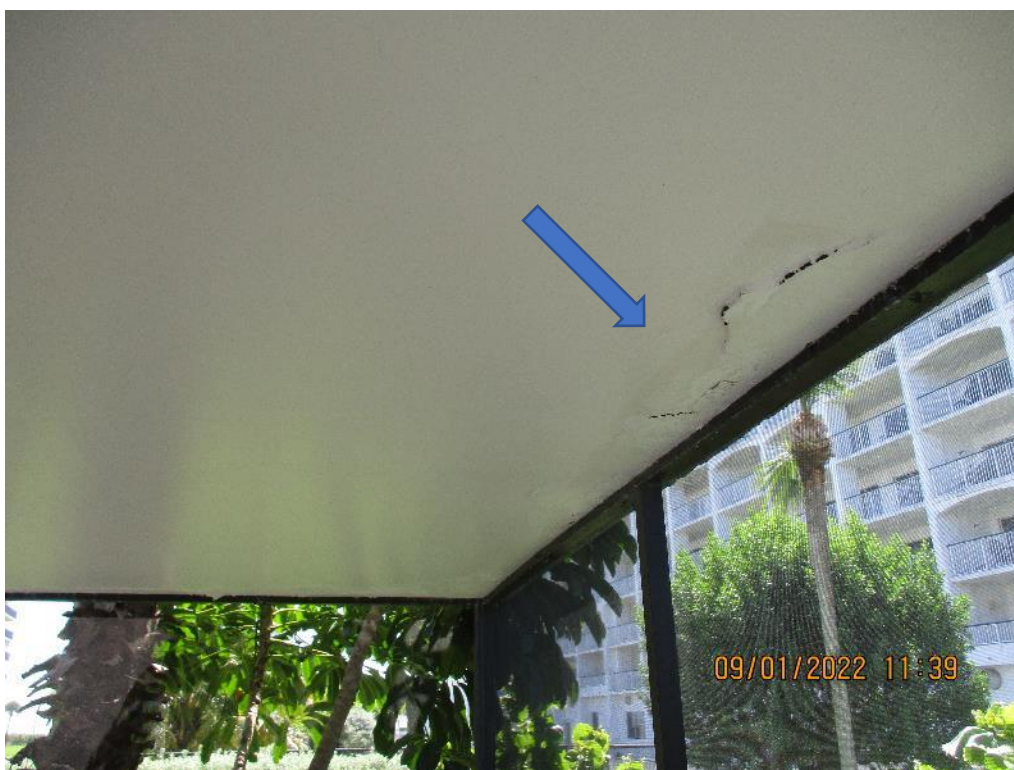
Concrete spalling due to reinforcing steel corrosion at balcony edge

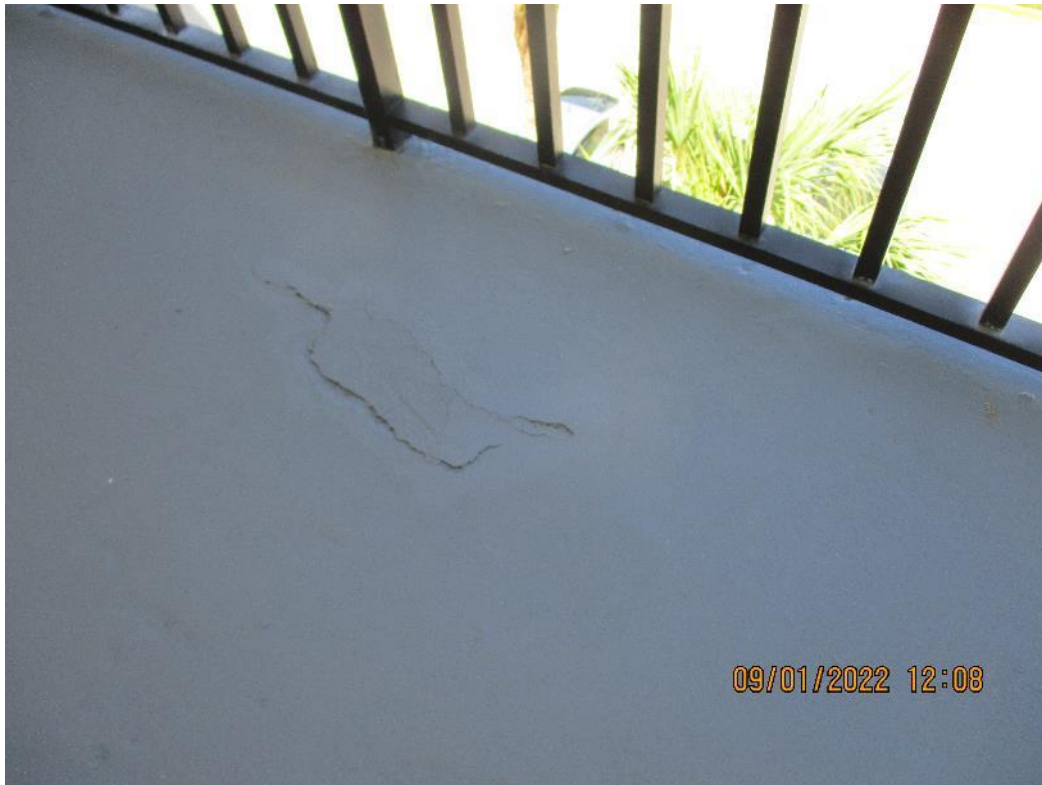
Surface spall along walkway

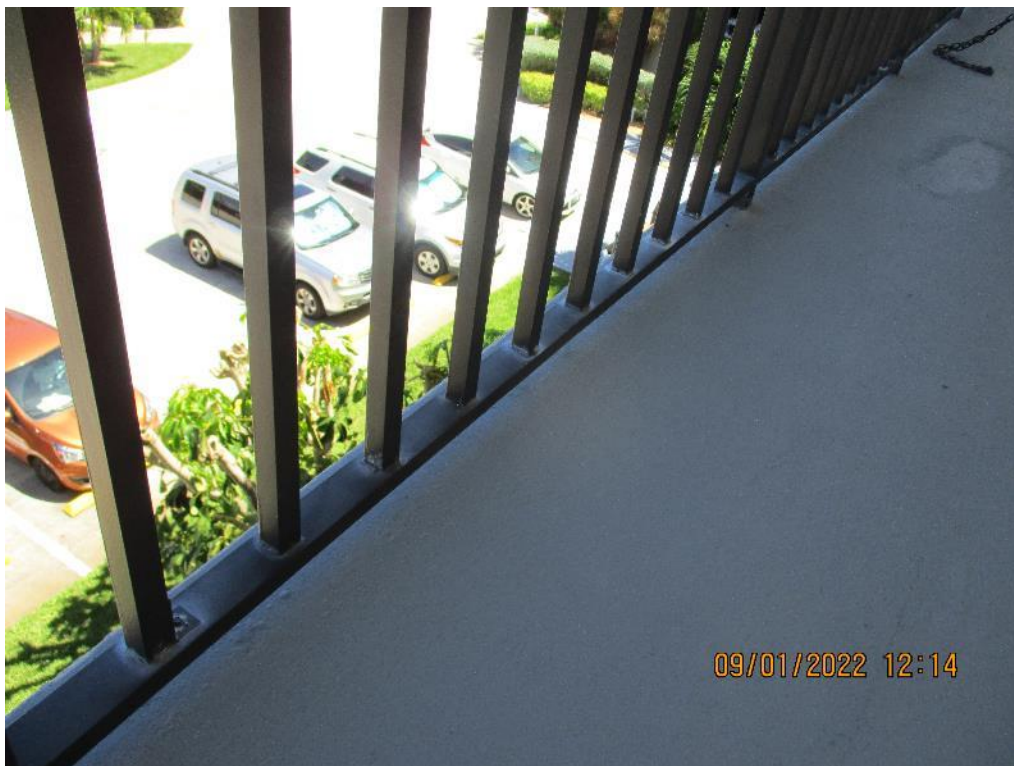
Deteriorated railing pickets along walkway

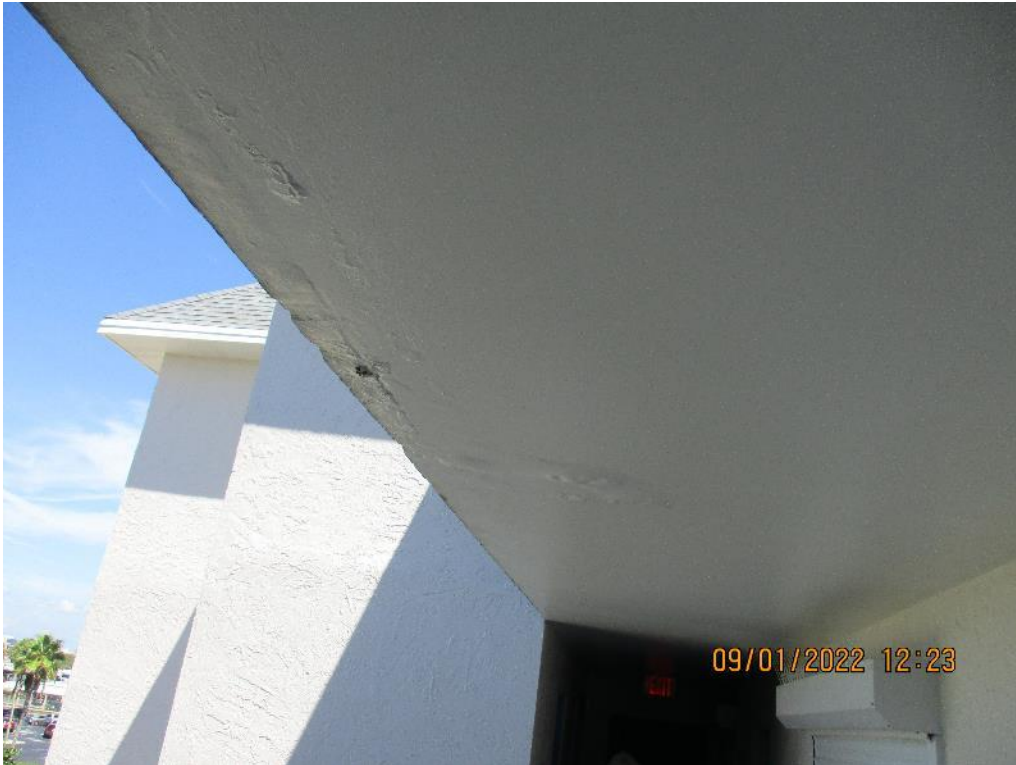
Edge spall on walkway

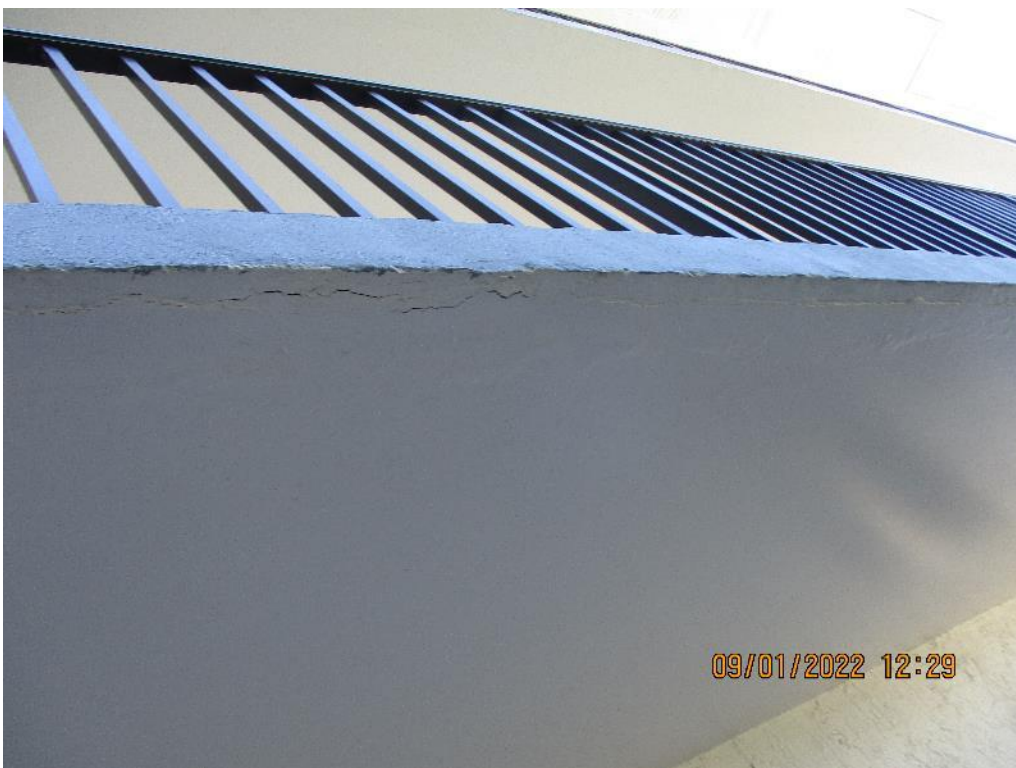
Edge spall on walkway

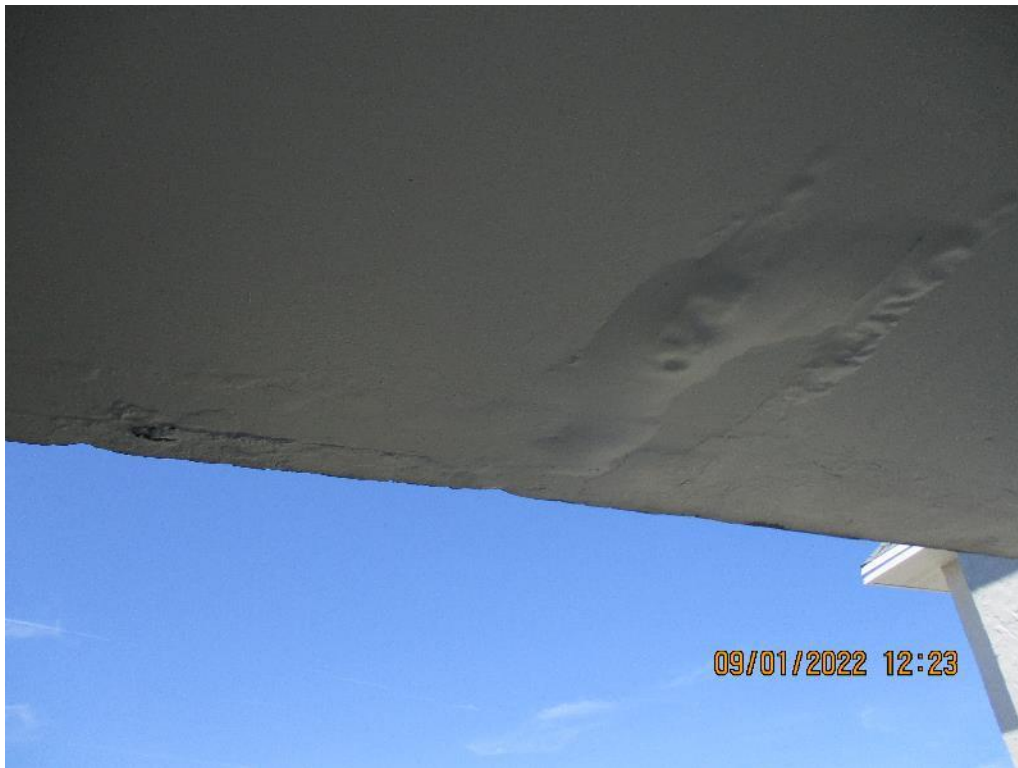
Example view of apparent water intrusion at walkway ceiling
